# PRINCE GEORGE'S HOSPITAL CENTER FACILITY ASSESSMENT REPORT

AUGUST 2013

The following report provides the findings of the facility assessment. The assessment goal is to provide an overall evaluation of the facilities to assist the planning process for maintaining, replacing, and/or modernizing space.

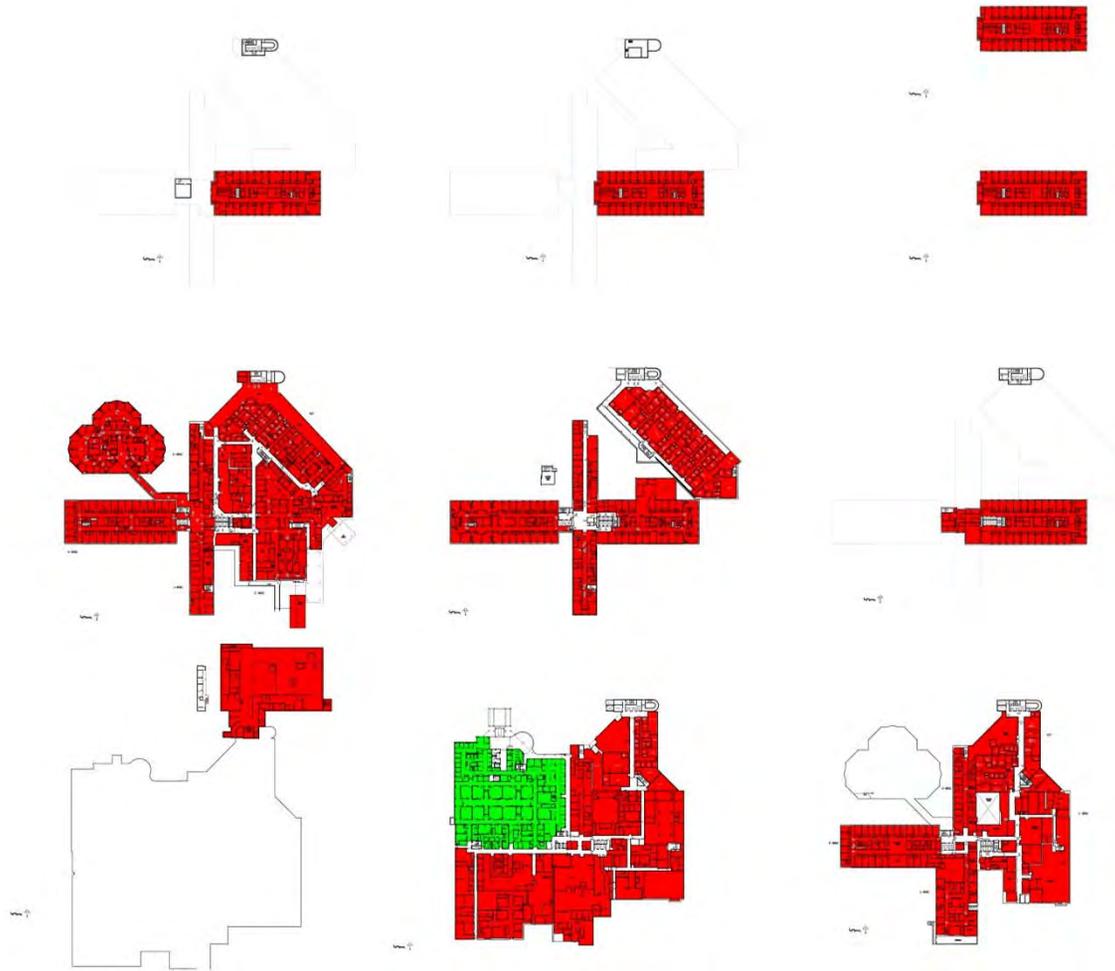
The Structural Grid does not meet the minimum 30'X30' size and in most areas has an irregular pattern, making it difficult for adjustments.

Ceiling heights are below the industry standard (16' for diagnostic floors and 14' for patient units floors).

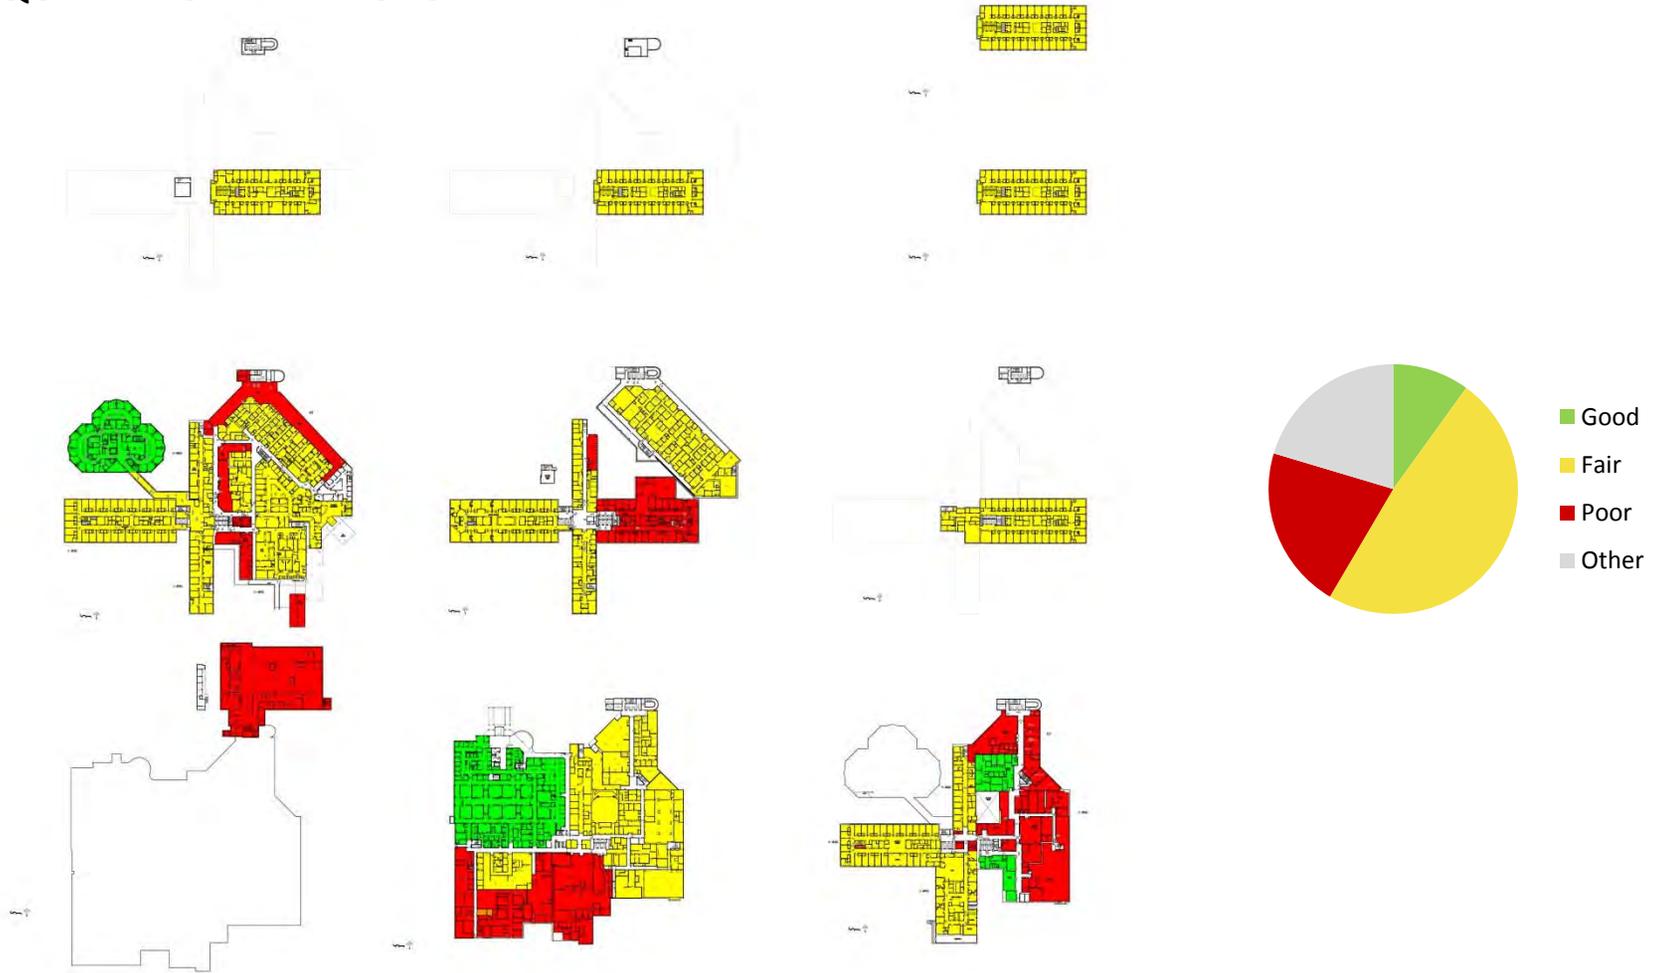
- The hospital has a institutional look which does not support staff and patient comfort.
- Some programs are too small to meet their goals.
  - Some programs such as SAC and Gym lack supporting space including shower and lockers space.
  - Staff spaces and counseling units need more and larger group rooms and conference rooms.
  - Double occupancy patient rooms are common, although this is not current best practice
  - A majority of the toilets do not comply with ADA.
- Some areas have old and deteriorating finishes.
- Some staff work spaces can be noisy, crowded, and cluttered.
- Some spaces such as lab and medical imaging archive are dated considering today's modern healthcare operations.

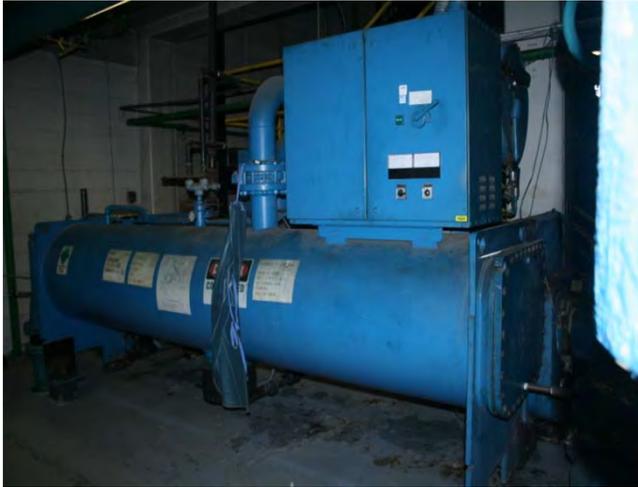
System	Description	Est. Life	EVAL.	Comments
Chiller System	(4) 450 ton Carrier Units vintage 1996; 18 years old. R-22 refrigerant. Primary pumping delivers chilled water to buildings; and secondary pumps provide pumping at several building additions. The delivery temperature is 42F and returns with 10-12 degree delta T. A water side economizer is present, but not operational due to inadequate commissioning.	<5 years		Chiller tonnage is short at PGH; and requires expansion. Some AHU's have short capacity, but there is a primary deficiency in cooling capacity during peak summer season. The ACF addition in 1979 used decoupled DX heat pump systems. R-22 is not an environmentally safe refrigerant, requiring these units to be replaced sooner rather than later with a safer refrigerant. Utilization of the water side economizer would reduce utility costs were it operational
Cooling Towers	(3) 750 T Evapco Cooling Towers were installed in 2011. Tower capacity matches chiller capacity. Exterior condenser water piping is substantially pitted. Some surface rust is evident on the tower basins.	10 years		Tower tonnage matches chiller tonnage and since the chillers are at capacity, the towers are at capacity and have no spare capacity. Condenser water piping will require repair or replacement when leaks occur.

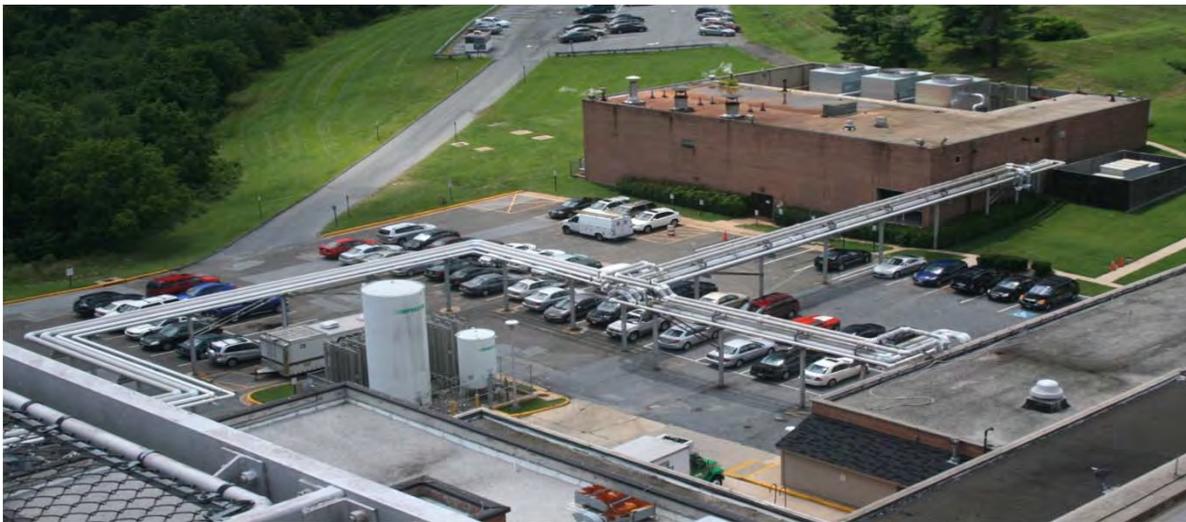
Piping Distribution

System	Description	Est. Life	EVAL.	Comments
CUP Distribution	Chilled water and steam are routed on an elevated and exposed piping rack throughout the grounds. The system was installed in the 1980's and has been tapped as necessary to feed new buildings as they come on line. No leaks are evident.	10 years		Chilled water piping is at capacity. Substantial additions will require upsizing the mains from the tap point back to the point of distribution. Central steam piping is expected to be in adequate condition, however, the steam condensate piping is nearing the end of its beneficial life and it is expected to begin having reoccurring leaks within the near future.
Deaeration and condensate collection	The facility is utilizing its second deaerator. The internals of the first unit failed. The shell is being used as a surge tank that feeds into the deaerator.	5 years		Deaerators are subject to much corrosion and will eventually leak. The original tank being used as a surge tank will probably fail sooner as it has been exposed to corrosion potential longer. Typical condensate return is about 80%, however, only about 40% is being returned to the CUP necessitating a large amount of makeup and increasing operating costs.

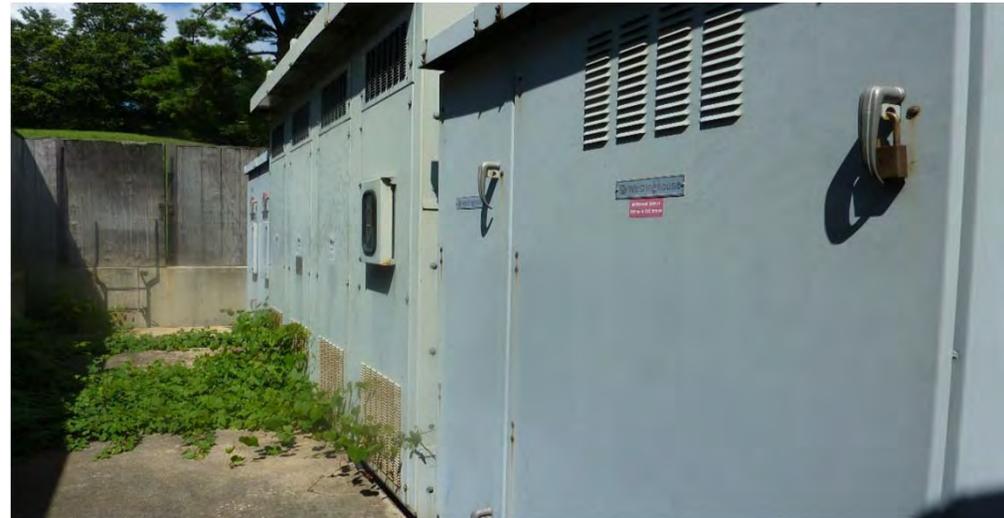
Exterior ISP Substation

CUP Normal Electrical Distribution	CUP gear is 4160V Double ended substation transformers rated at 1887 amps. Main breakers are rated at 2500A and the Current loading is 900A on Main 1 and 1200A on main 2.	5 yrs		If operating from one side can run only 2 chillers and MCC's. Project in place to add a portable generator connection to serve 2 chillers. Cup gear no longer can function with N+1 as intended. Capacity and age of equipment requires replacement.
Outdoor Normal Electrical Switchgear	Gear is 16 years old; is single ended with a primary select double cabinet and 480V, 3000A secondary. Gear serves the ISP, and wings J, K & H. Secondary feeder is routed along west side into K wing basement. Gear is 3000A with no main breaker.	20 yrs		Gear is in decent shape outside. The ICS switchboard in K wing basement has a single ended distribution. Gear could operate as long as estimated, but fails to meet code.

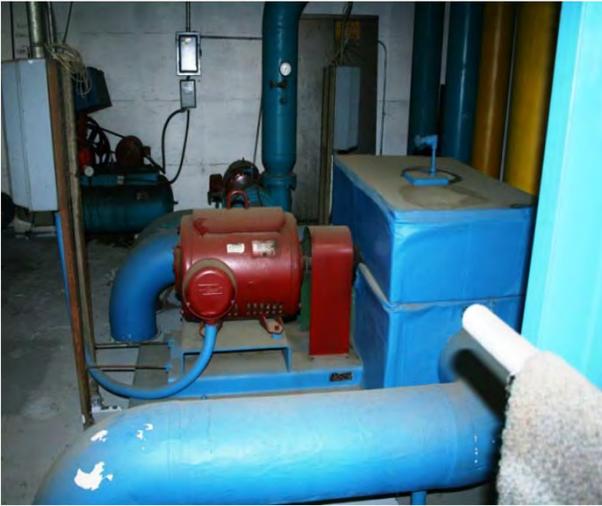
Water Pump

System	Description	Est. Life	EVAL.	Comments
Domestic System	WSSC compliant with adequate pressure and backflow prevention. Piping system and valves have recurring failure.	10 years	Yellow	Although service is adequate, system needs replacement and upgrading.
Fire Protection System	Two sets of fire pump systems, adequately pressurized. Facility only partially sprinklered.	5 years	Red	Building needs to be fully sprinklered to comply with current codes and life safety.
Domestic Hot Water System	Central water heaters are sufficient for load capacity and delivery. Piping system and valves have recurring failure.	10 years	Yellow	Although service is adequate, system needs replacement and upgrading.
Waste and Storm System	Capacity and system is aged, but operates sufficiently with expected maintenance and service for its age.	10 years	Yellow	Grease waste system is adequate and WSSC compliant, but piping system should be upgraded and replaced soon, prior to major system failure.

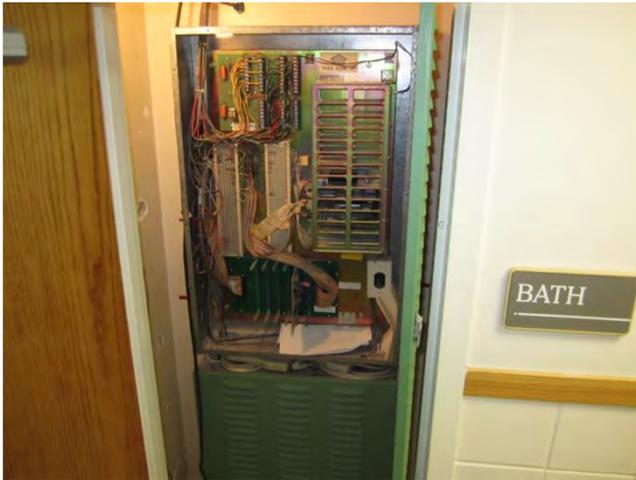
Typical closet with original nurse call system
