EXHIBIT 5

SUMMARY OF FACILITY DEFICIENCIES OF EXISTING PGHC FACILITY, BY DEPARTMENT

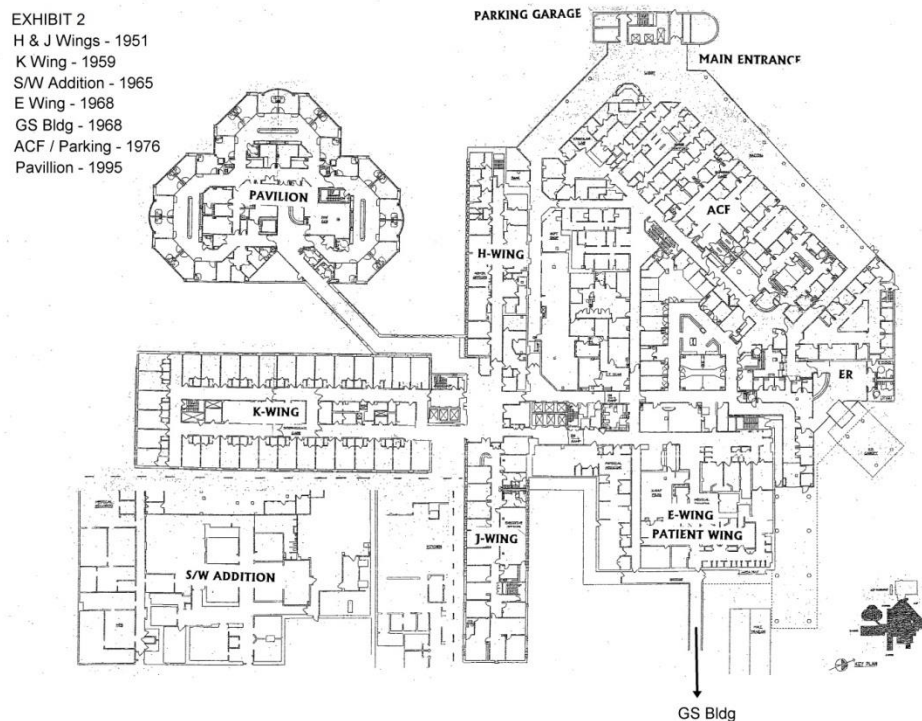
The existing facility is comprised of seven components from different eras. The majority of the building, including most of the inpatient units, was constructed in the period from 1951 to 1968. An ambulatory care facility and an intensive services pavillion were built in 1976 and 1995, respectively. A diagram showing the existing building and the years when the different components were constructed follows:
